# BOLTED FIELD REPAIR OF COMPOSITE STRUCTURES

J. C. Watson, et al.  
McDonnell Douglas Corporation  
McDonnell Aircraft Company  
P.O. Box 516  
St. Louis, Missouri 63166

Final Report

Repairs were demonstrated on both laminate thicknesses. The 3/16 inch laminate was typical of an AV-8B wing skin. The 1/2 inch laminate was typical of an F-18 wing skin. Three sizes of damage holes were investigated for each laminate thickness: 1.0 in., 2.5 in., and 4.0 in. diameters. Two repair concepts were evaluated for each damage configuration.

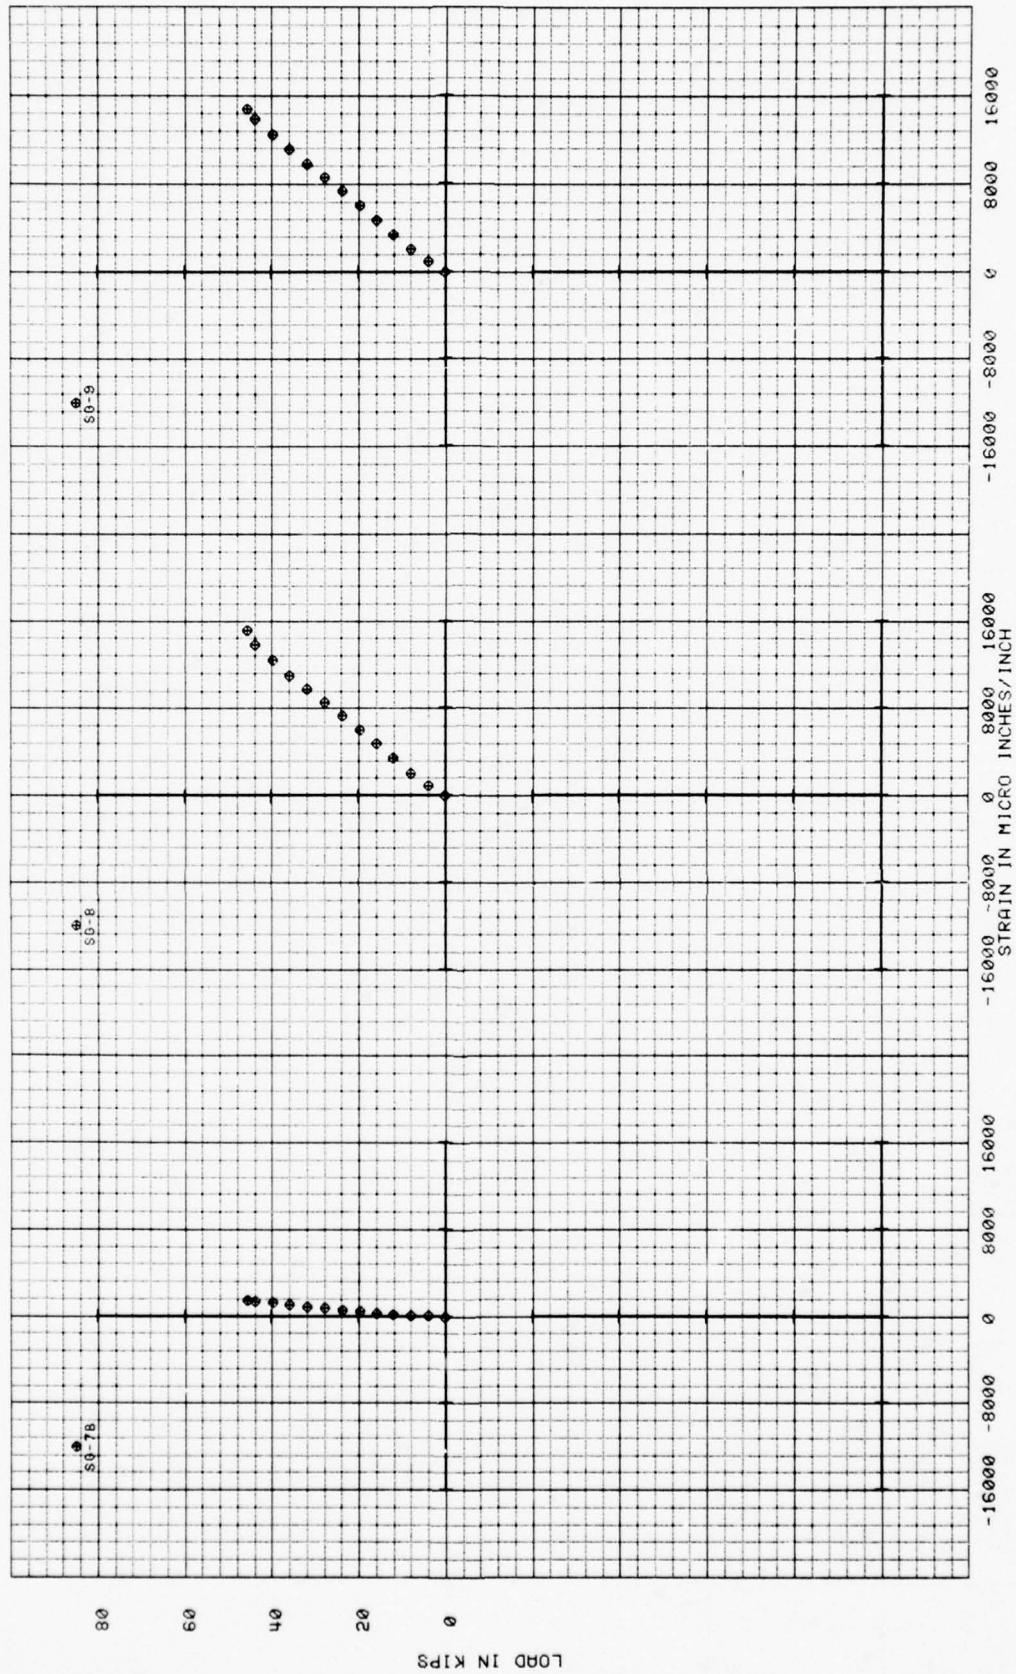
FIGURE B-8 Continued Strain Gage Data 75T060105-1005 No. 3  
3/16 Laminare 2.5 Dia Damage Hole

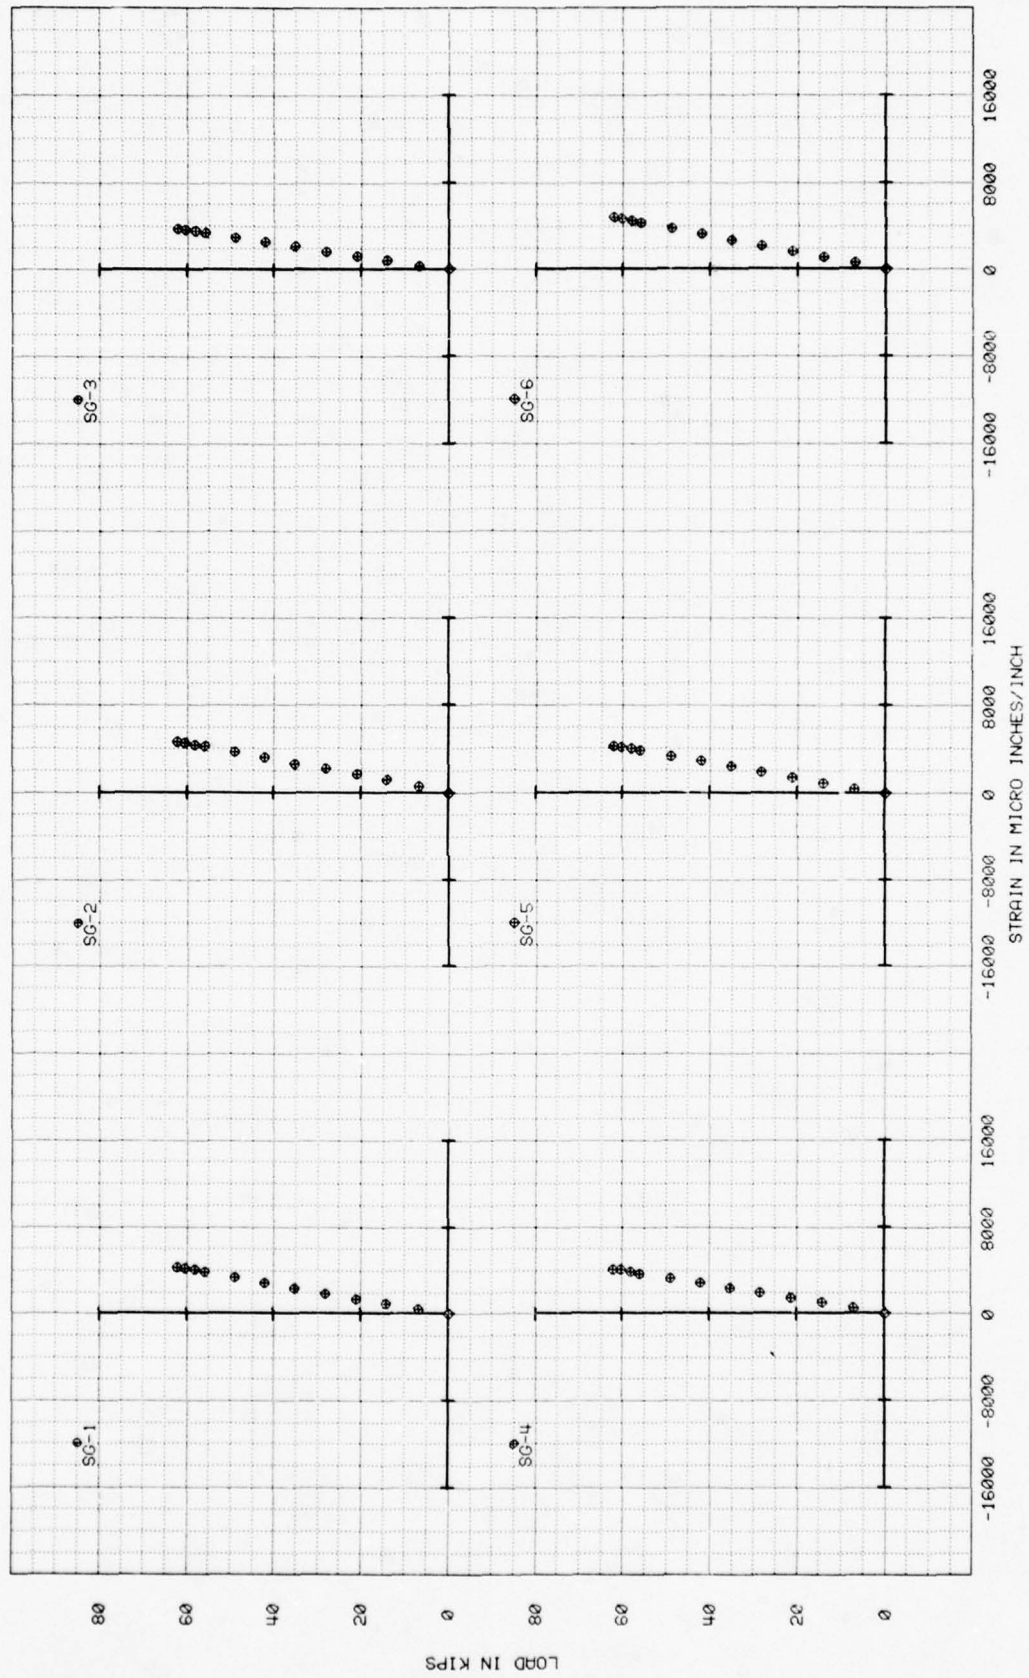
FIGURE B-9 Strain Gage Data 75T060105-1011  
3/16 Laminate 4.0 Dia Damage Hole

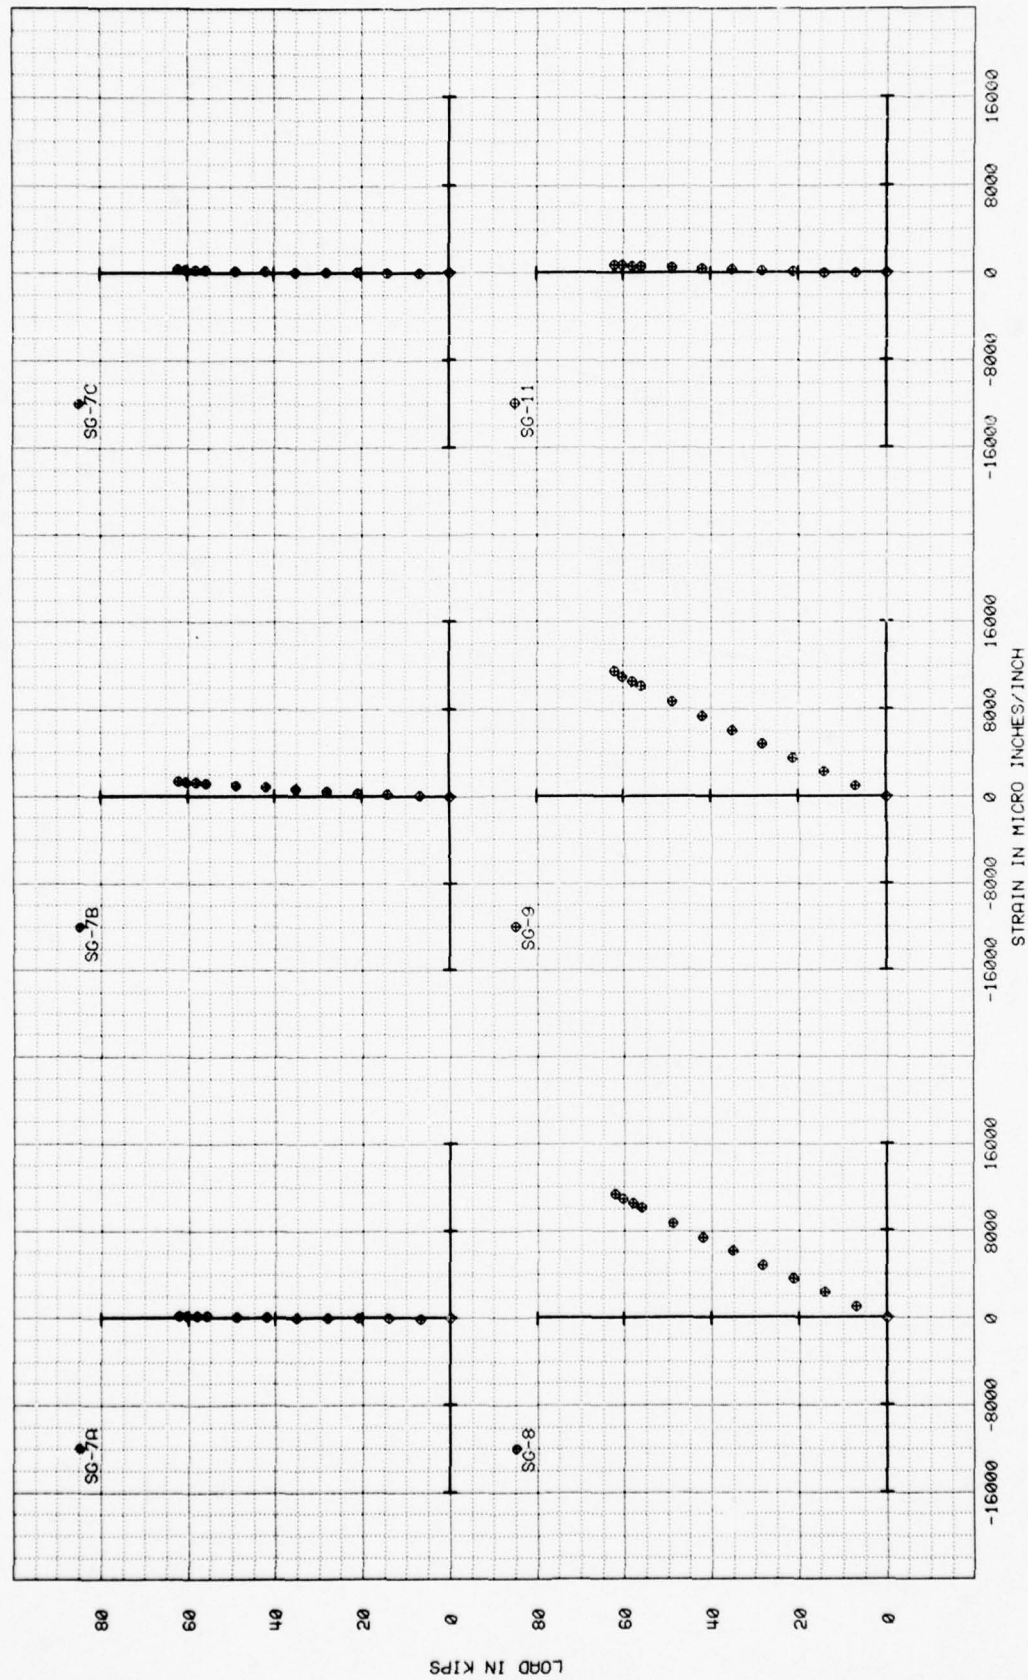
FIGURE B-9 Continued Strain Gage Data 75T060105-1011  
3/16 Laminate 4.0 Dia Damage Hole

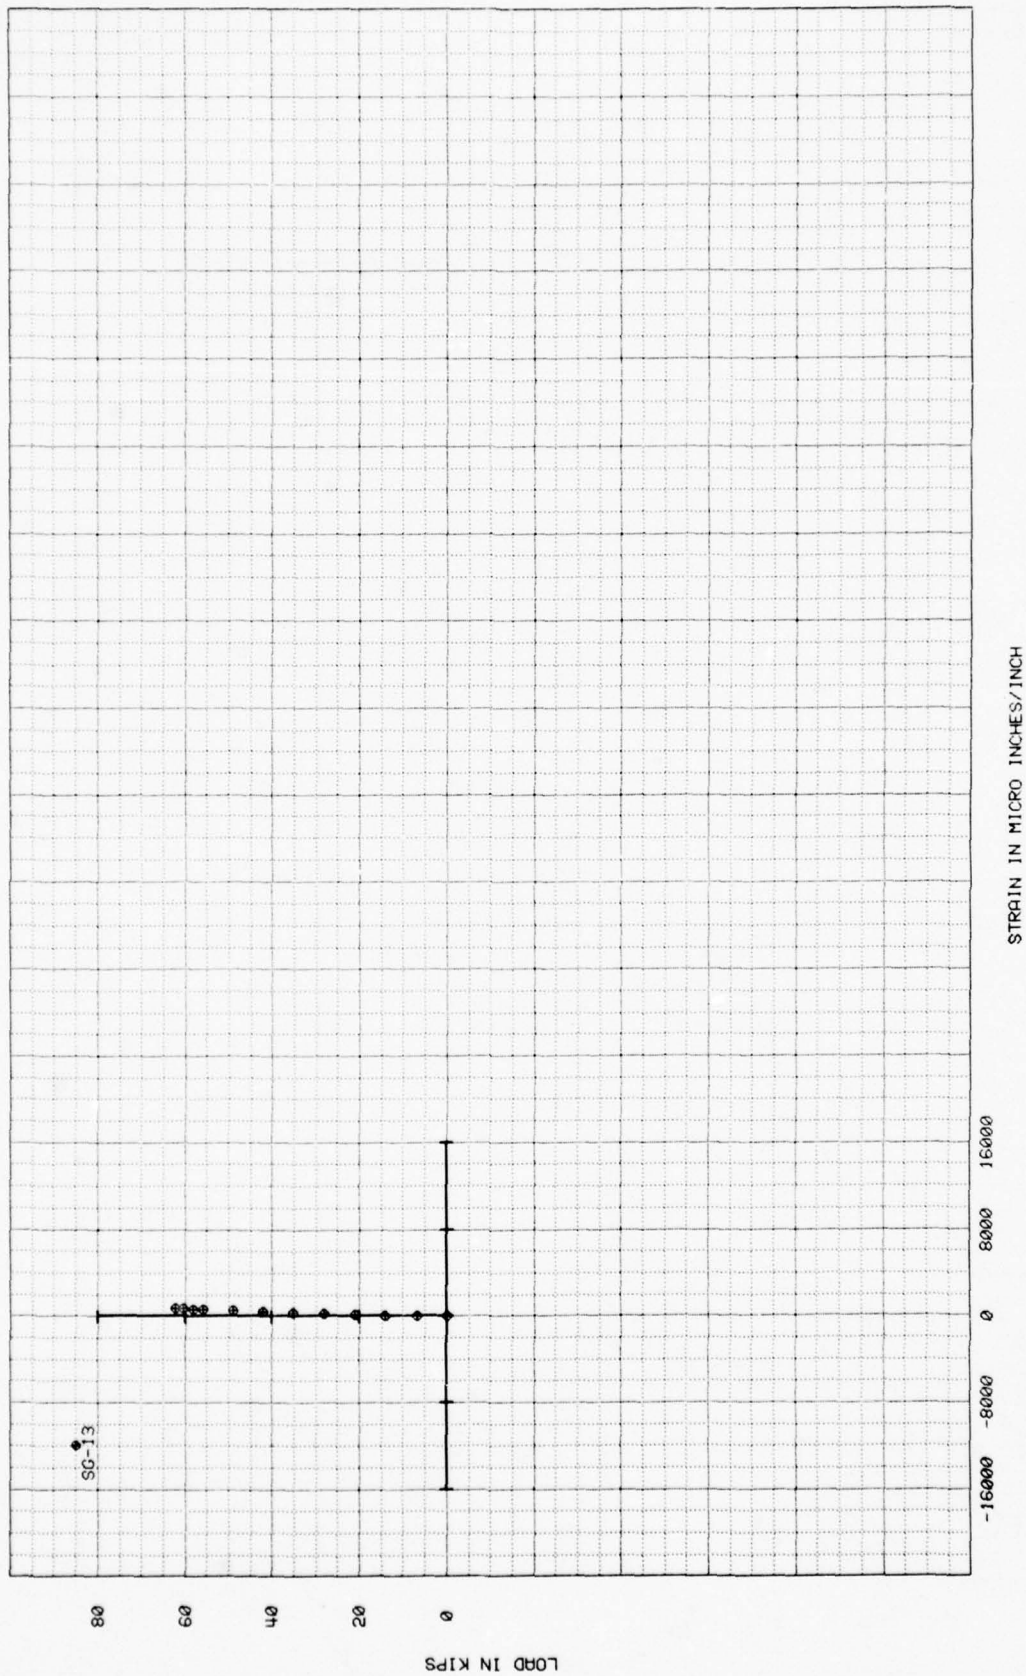
FIGURE B-9 Continued Strain Gage Data 75T060105-1011  
3/16 Laminate 4.0 Dia Damage Hole

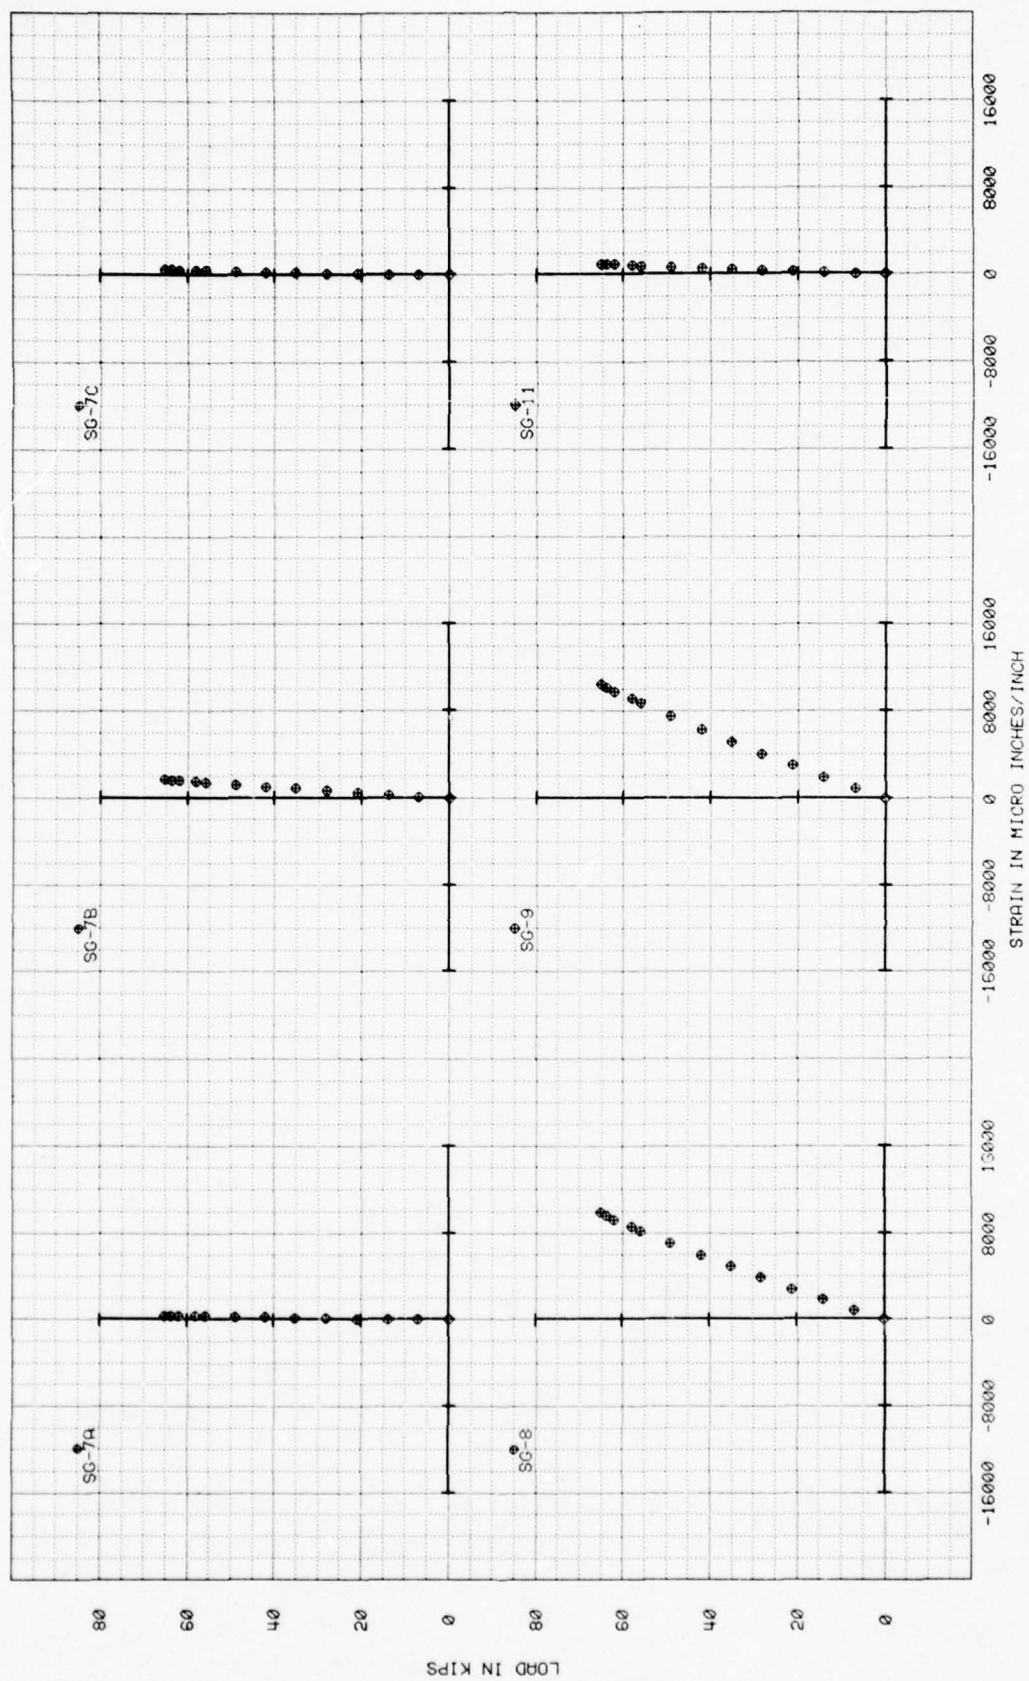
FIGURE B-10 Continued Strain Gage Data 75T060105-1013  
3/16 Laminate 4.0 Dia Damage Hole

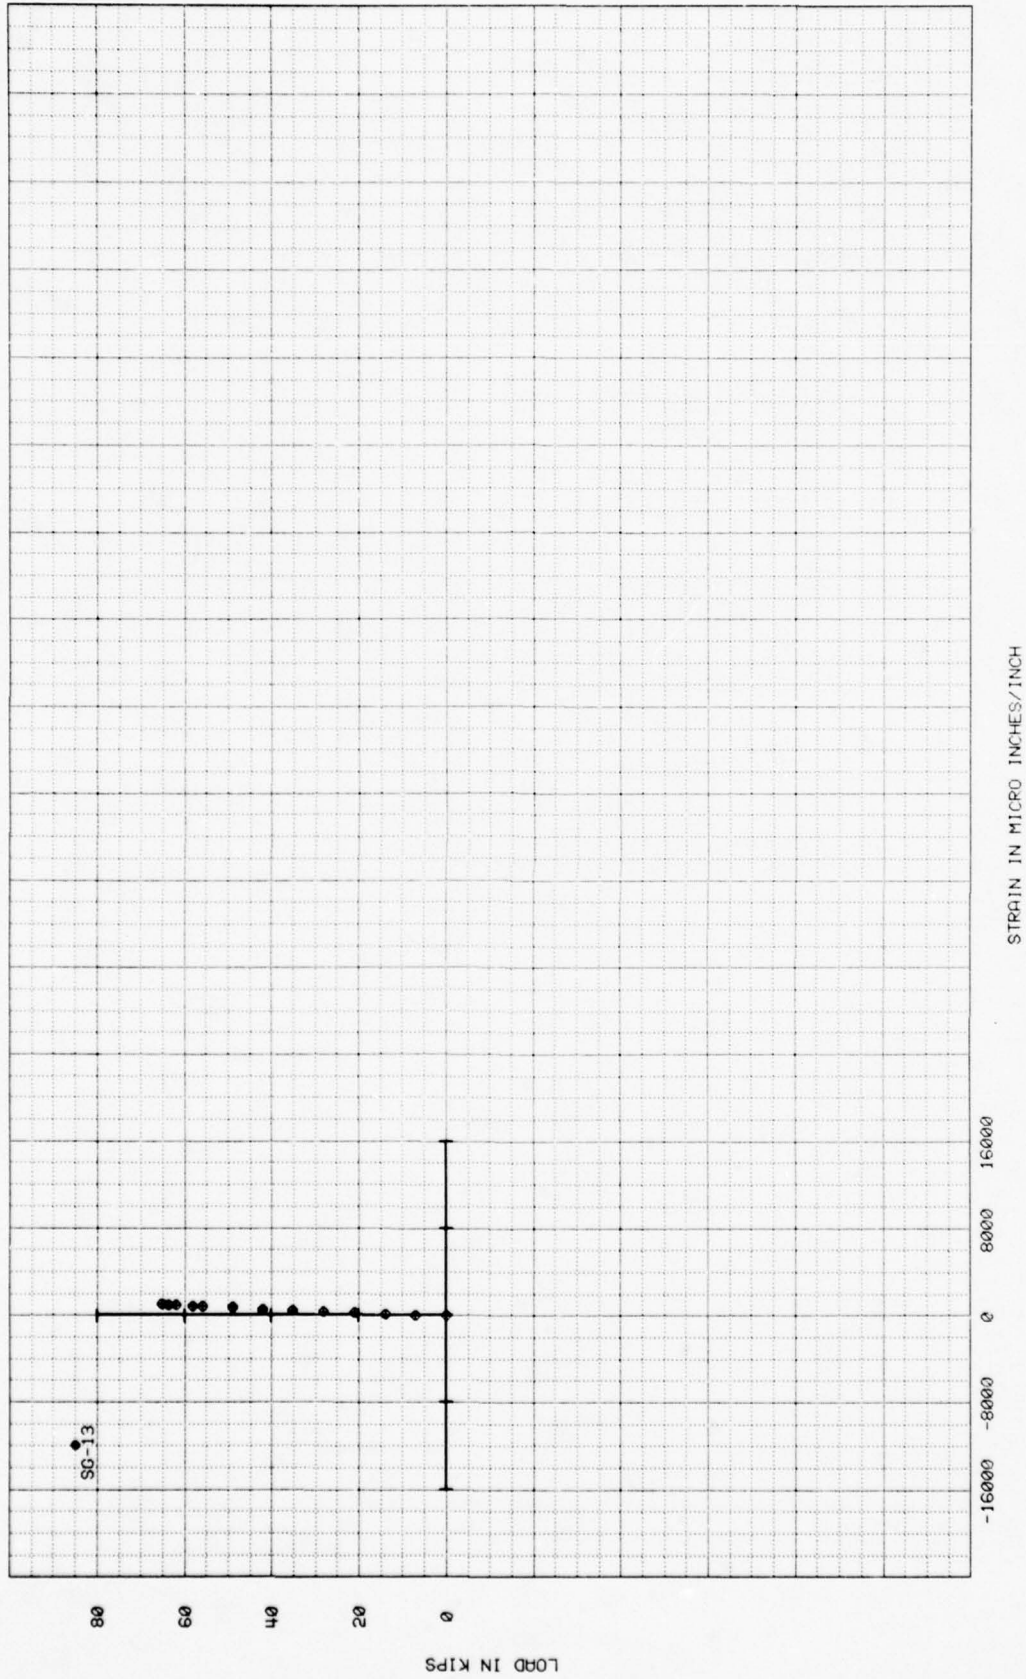
FIGURE B-10 Continued Strain Gage Data 75T060105-1013  
3/16 Laminare 4.0 Dia Damage Hole

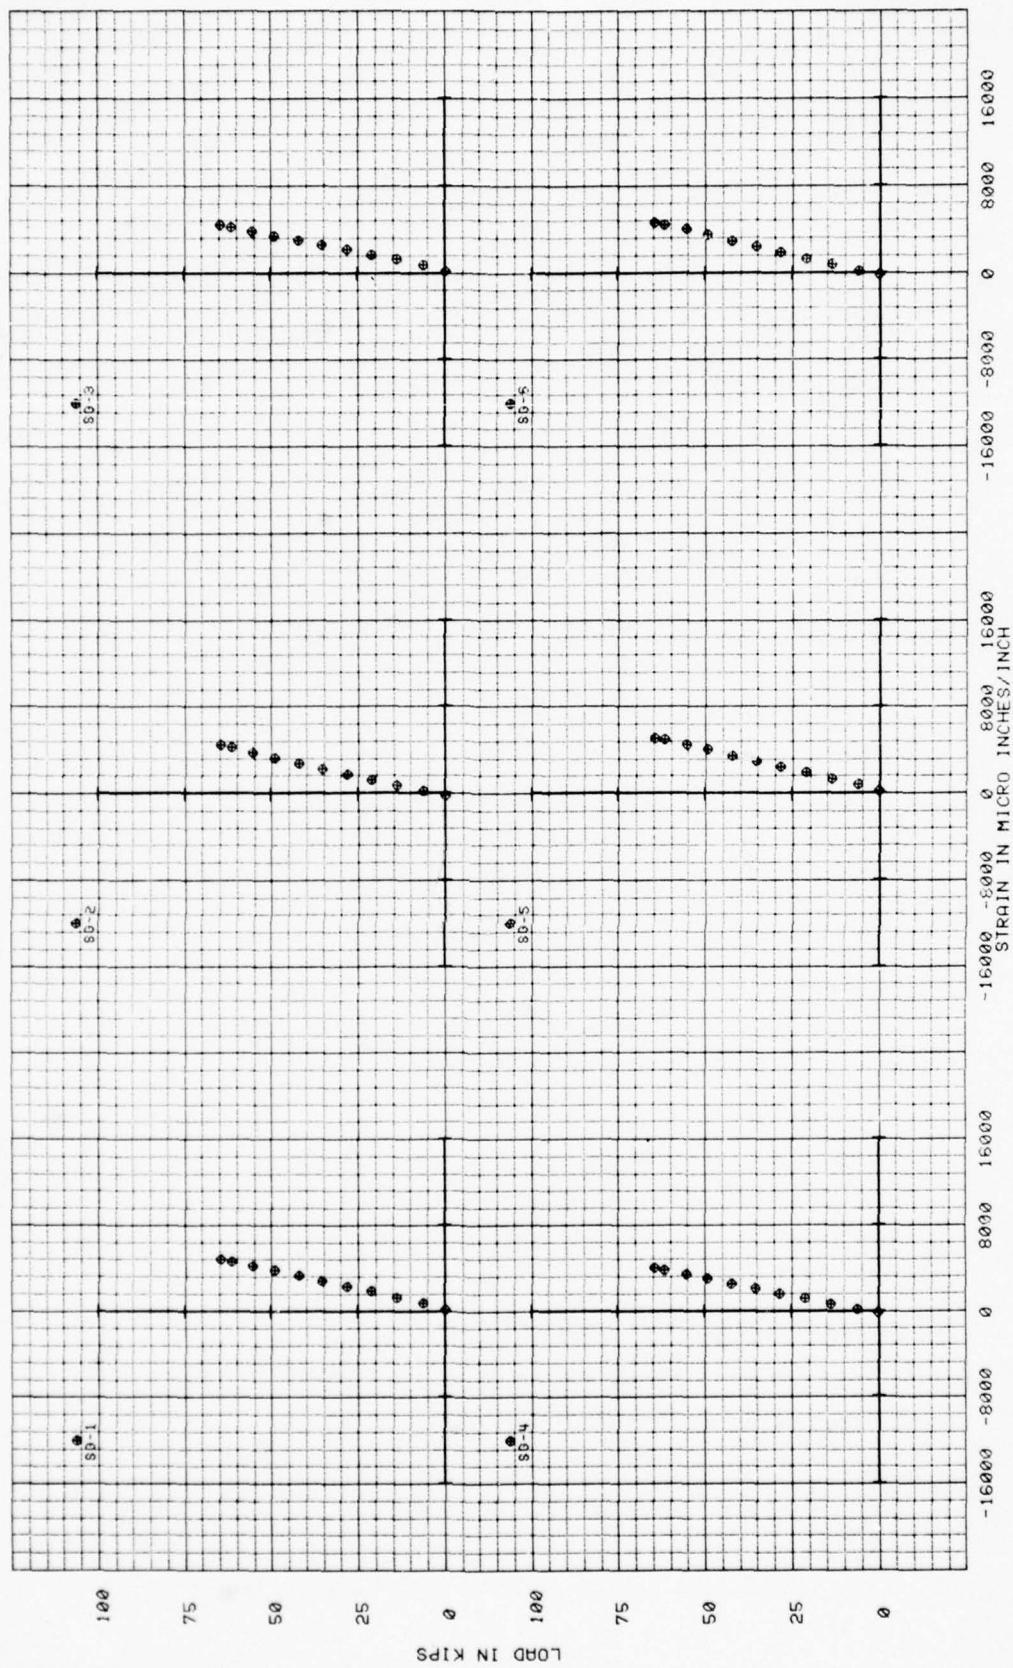
FIGURE B-11 Strain Gage Data 75T060105-1015 No. 1  
3/16 Laminate 4.0 Dia Damage Hole

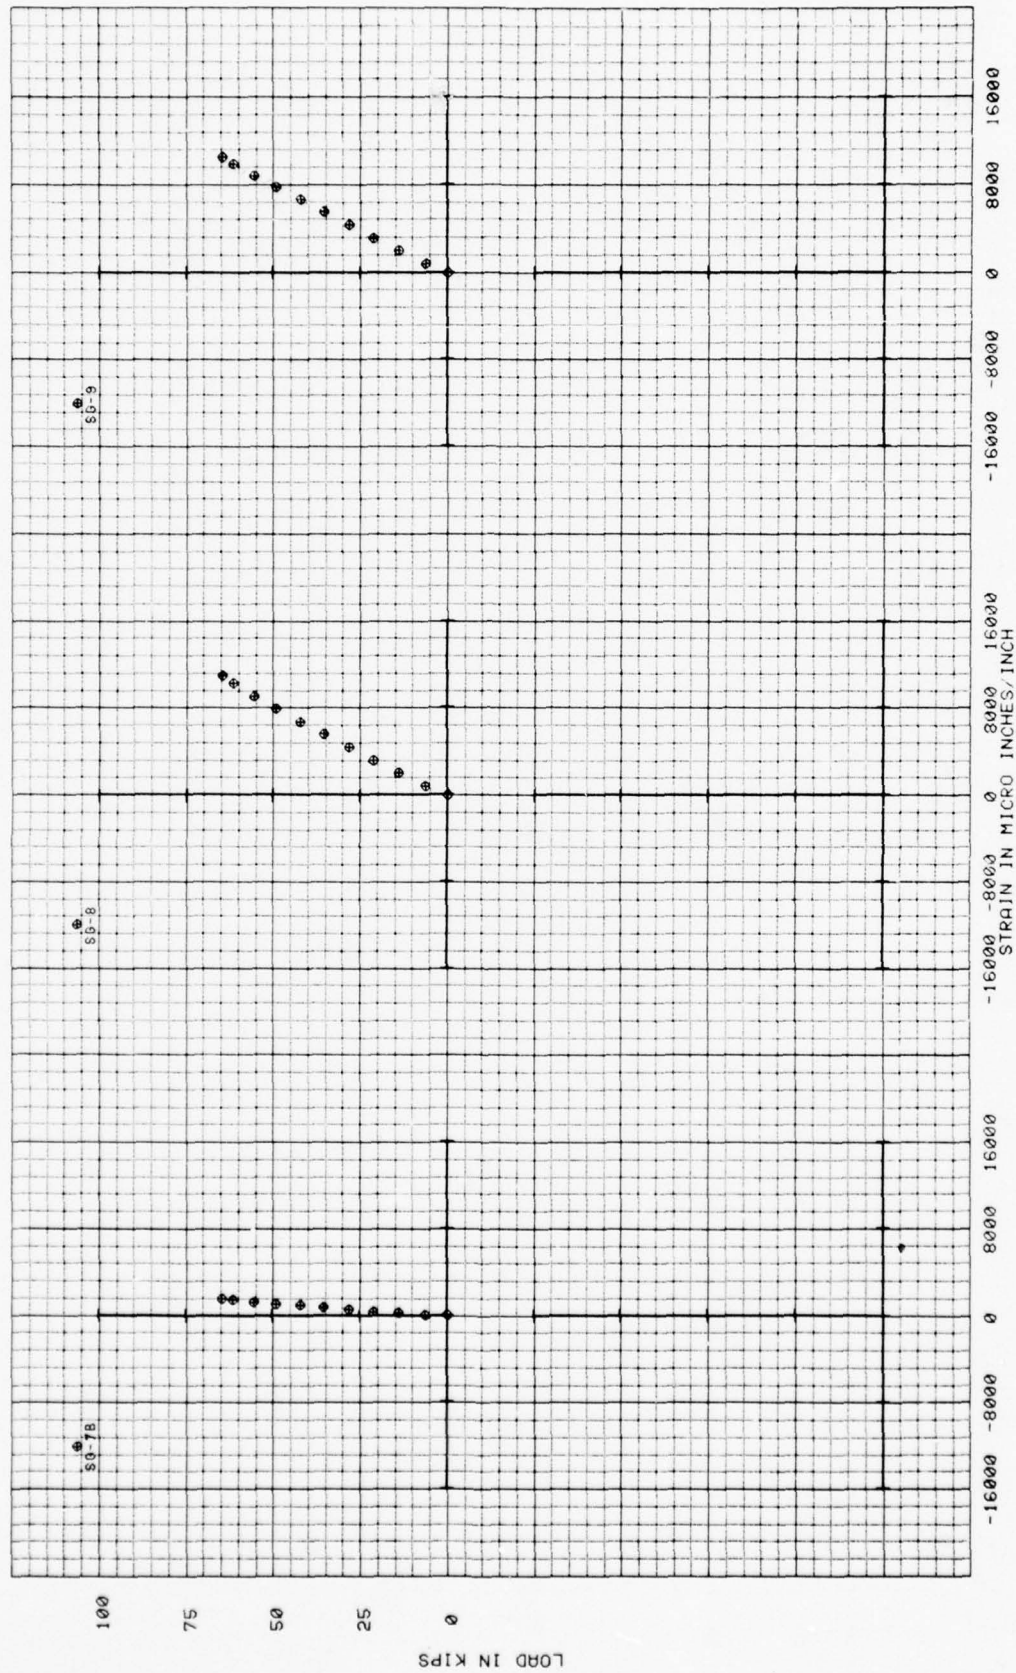
FIGURE B-11 Continued Strain Gage Data 75T060105-1015 No. 1  
3/16 Laminate 4.0 Dia Damage Hole

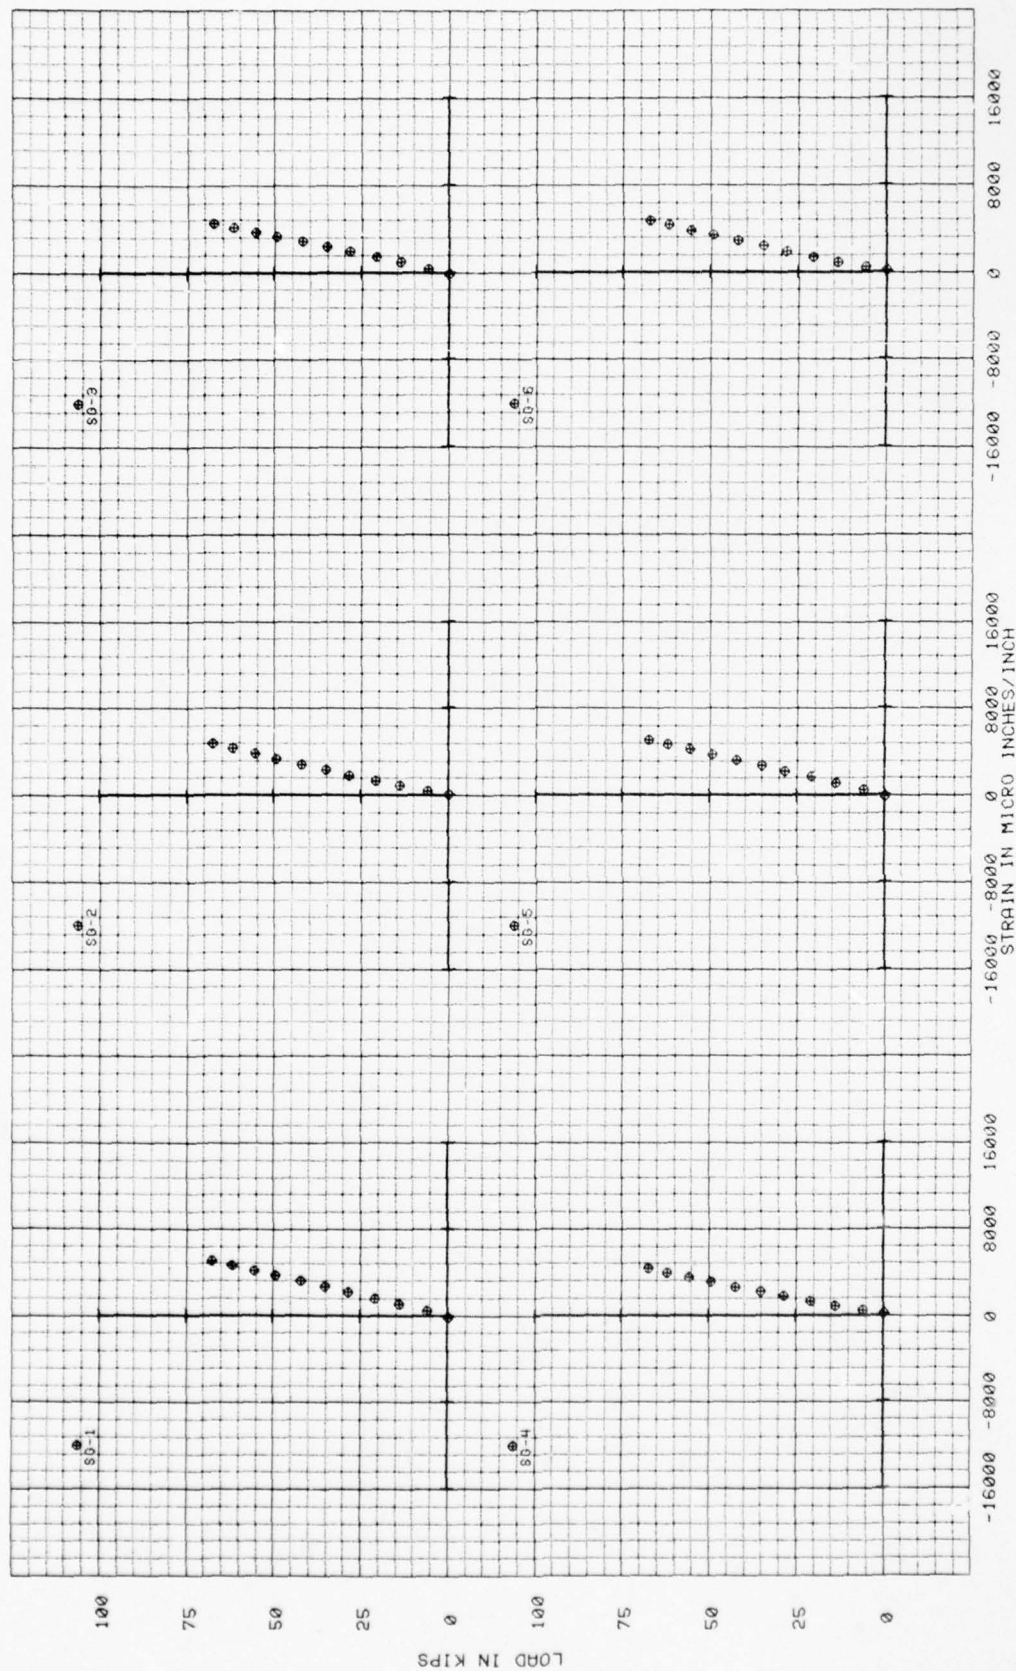
FIGURE B-12 Strain Gage Data 75T060105-1015 No. 2  
3/16 Laminate 4.0 Dia Damage Hole

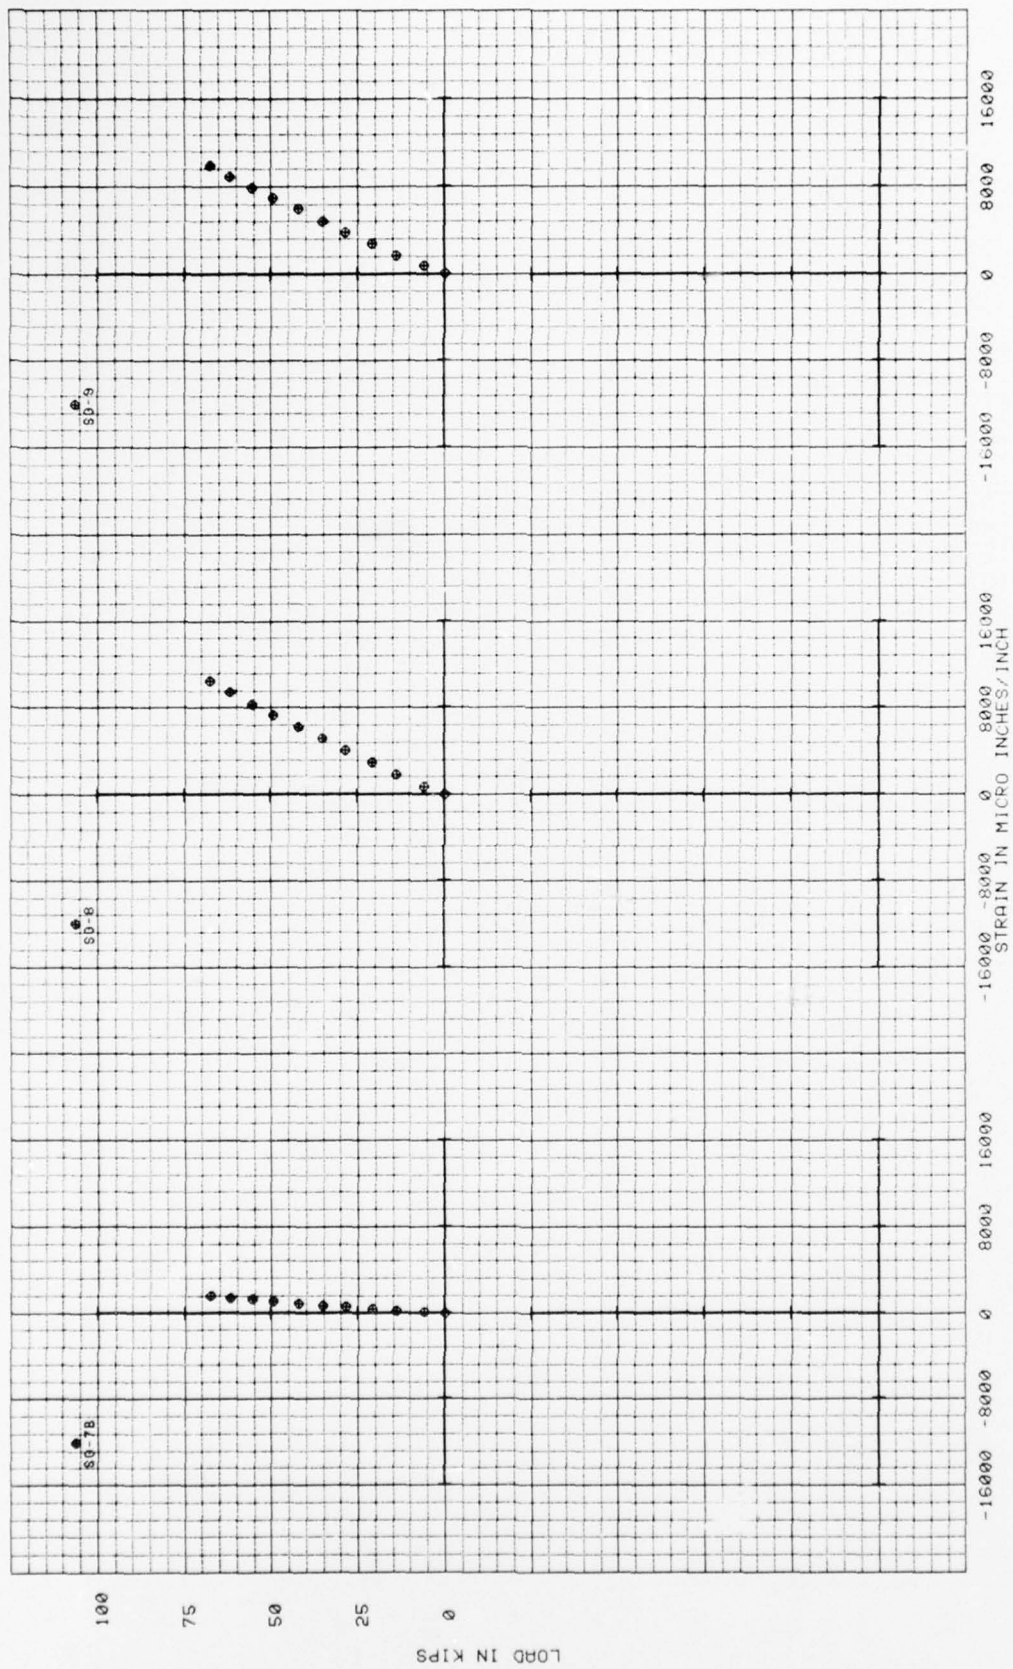
FIGURE B-12 Continued Strain Gage Data 75T060105-1015 No. 2  
3/16 Laminate 4.0 Dia Damage Hole

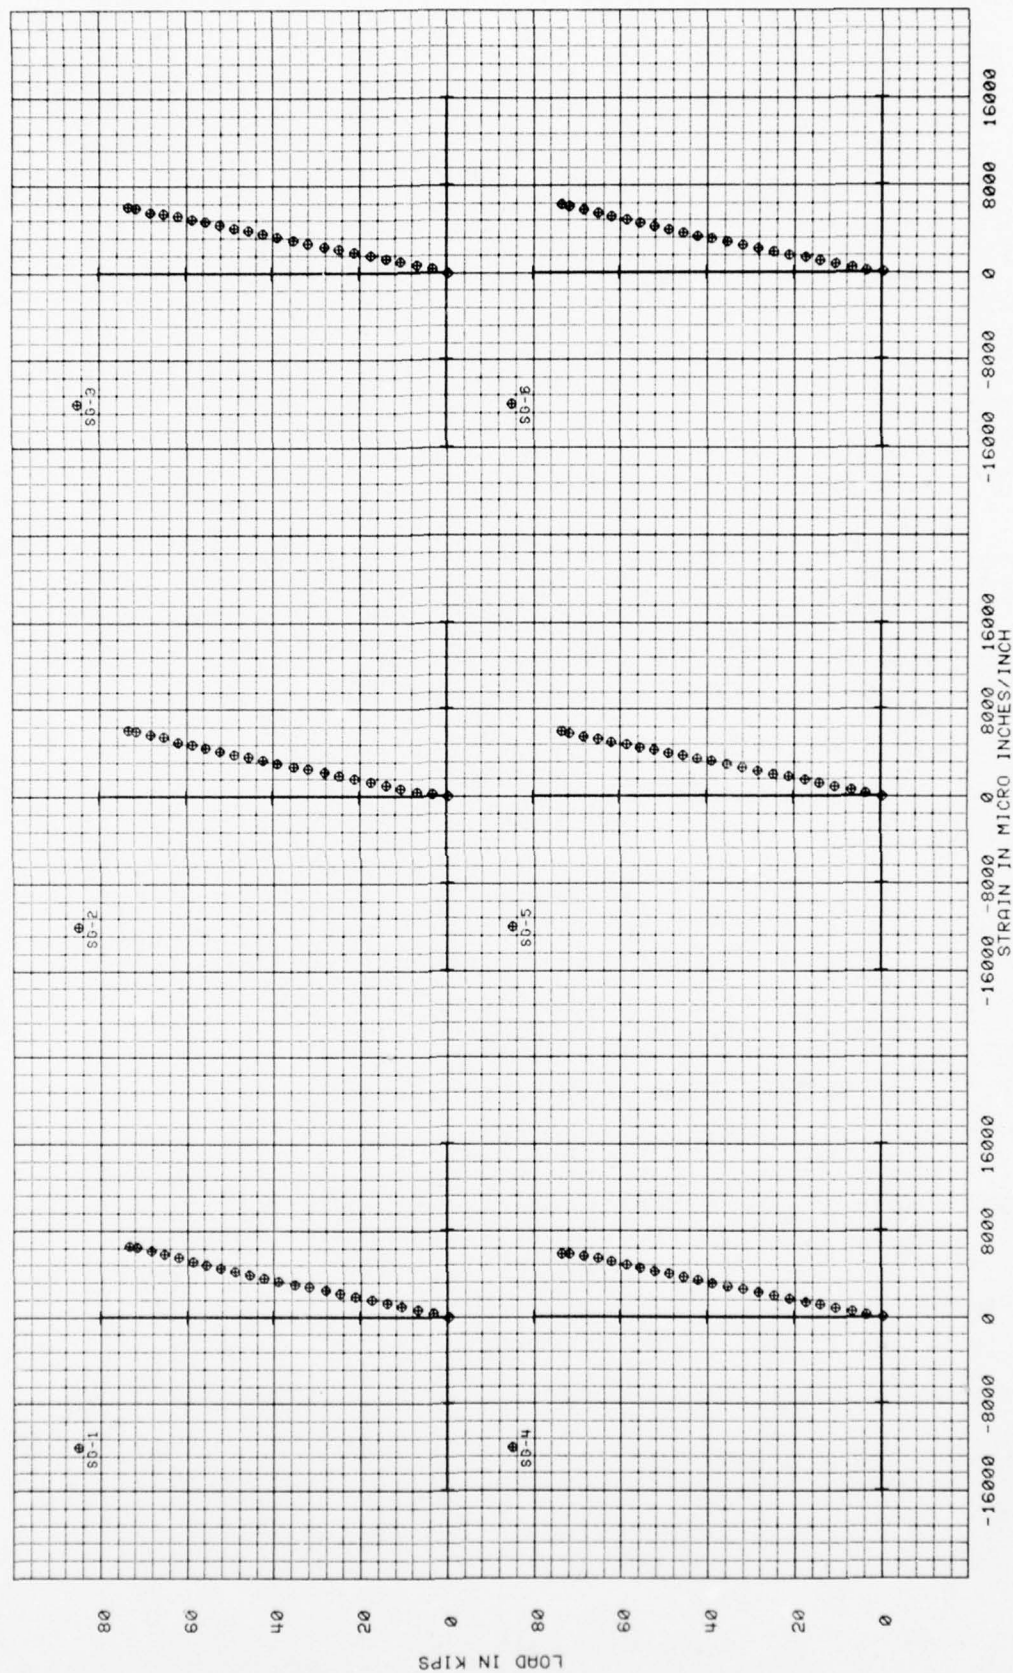
FIGURE B-13 Strain Gage Data 75T060105-1017  
3/16 Laminate OFF Axis

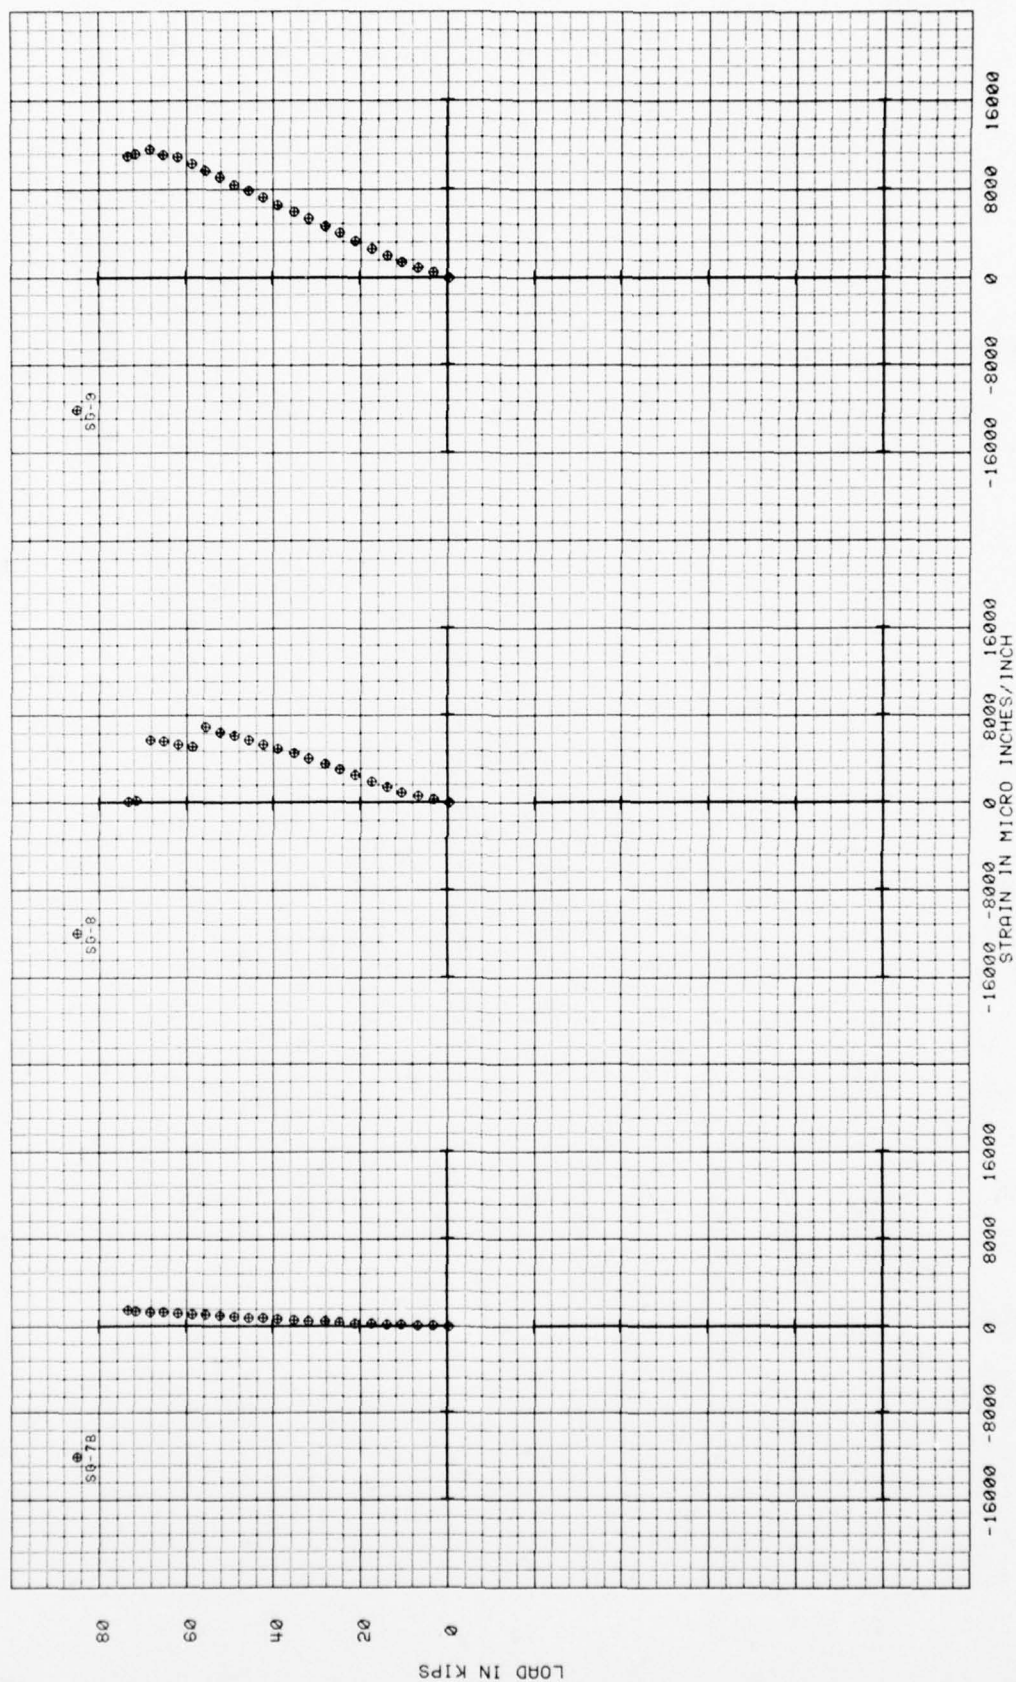
FIGURE B-13 Continued Strain Gage Data 75T060105-1017  
3/16 Laminate OFF Axis

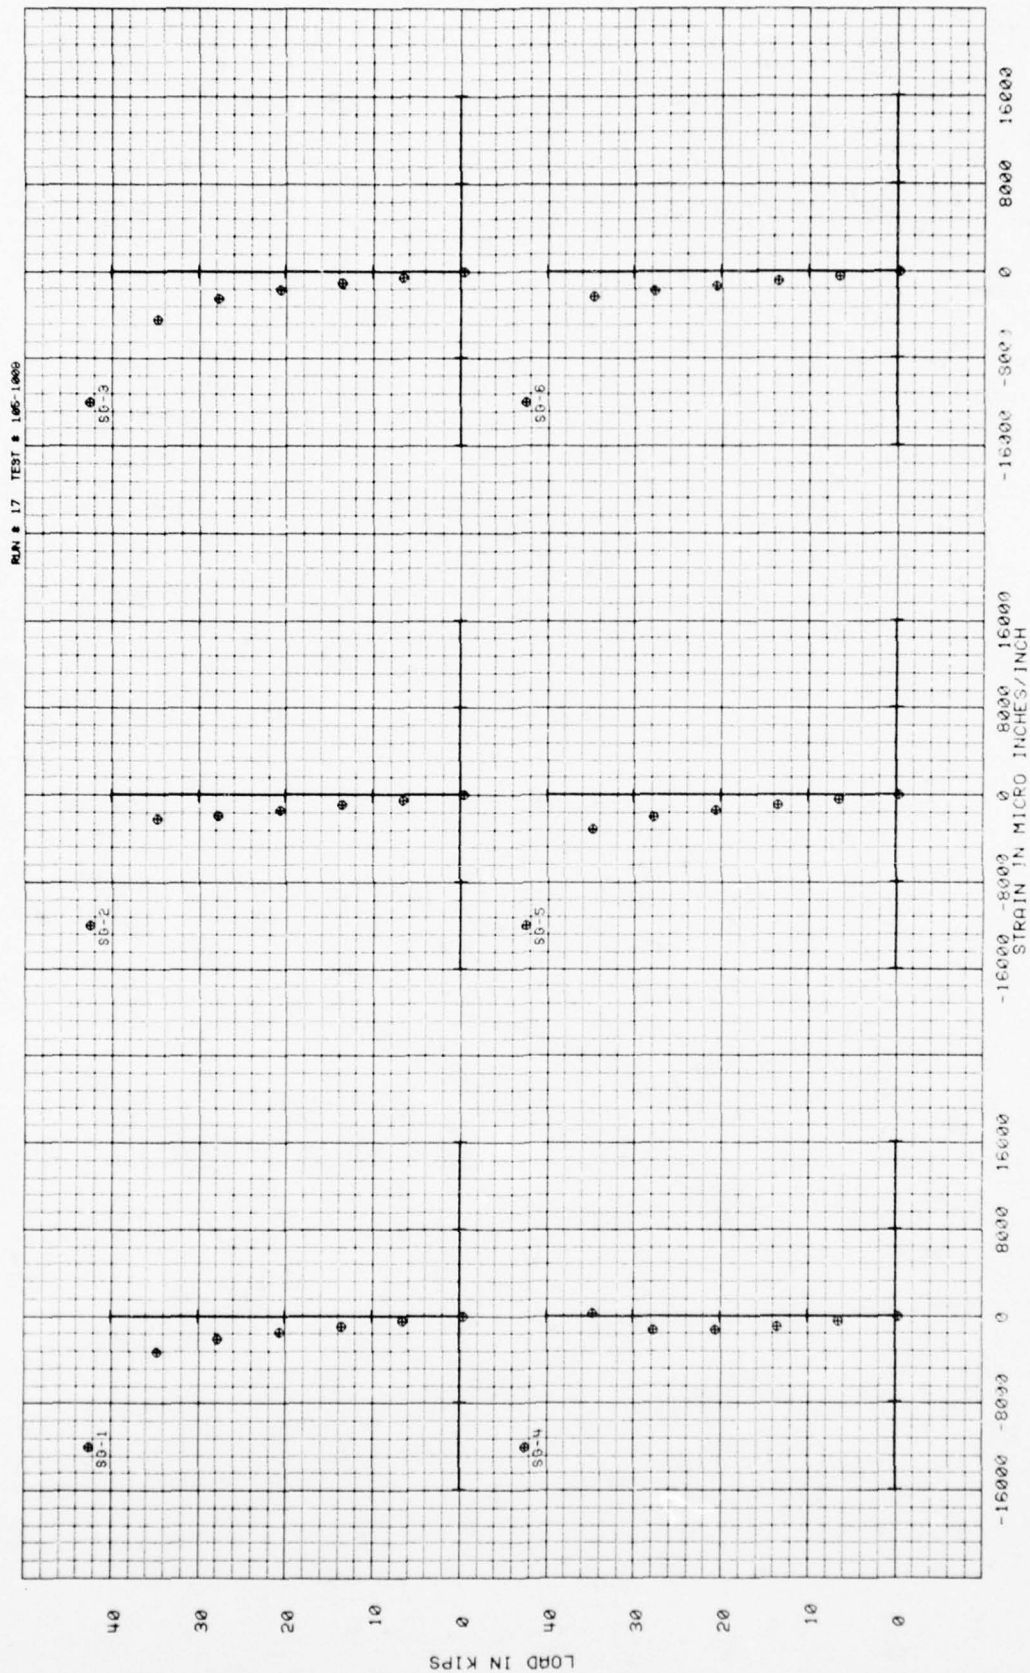
FIGURE B-14 Strain Gage Data 75T060105-1009  
3/16 Laminate Compression
